Lost River Restoration

Monitoring Report 2016

Nate Catterson, Fisheries Biologist

Yakutat Ranger District, Tongass National Forest

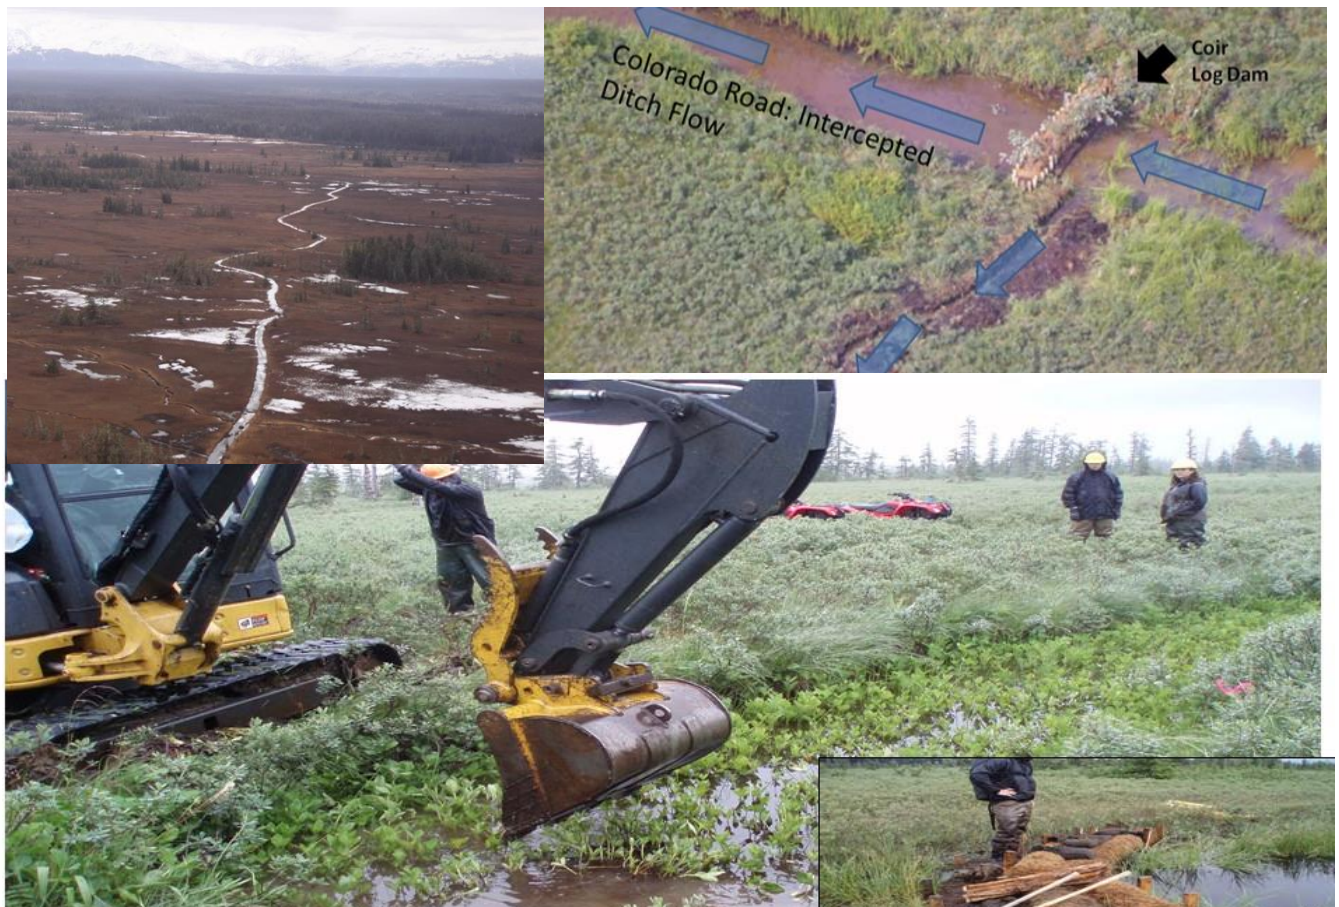
Fig 1. (Top Left) The Colorado Road altered hydrology in the Lost and Situk River Watershed. (Top Right) Coir log dams divert water back down the original channels. (Lower) An excavator is used to remove vegetation from a dewatered channel. (Lower Right) Coir log dam

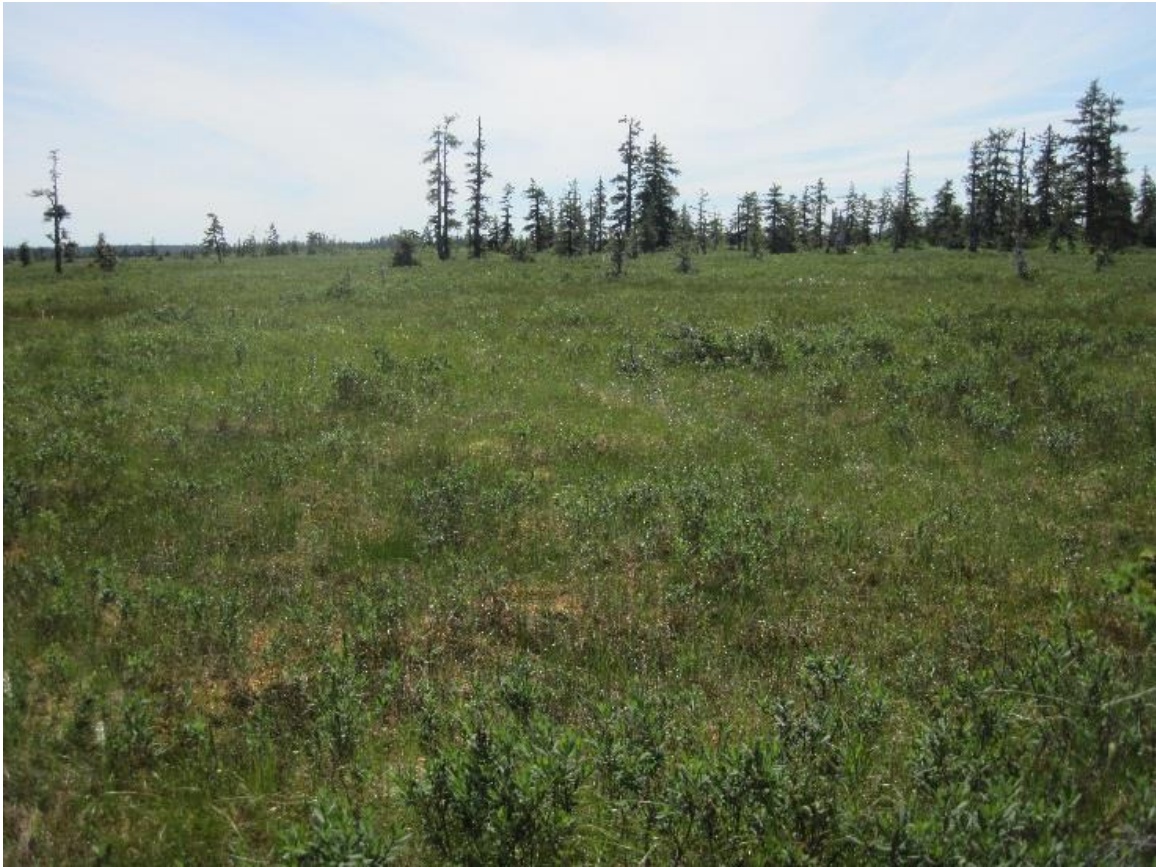
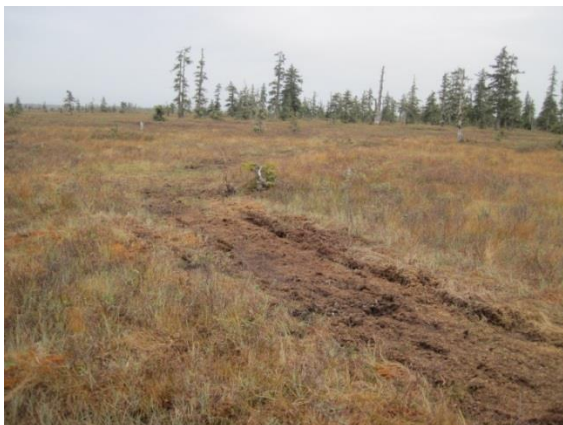
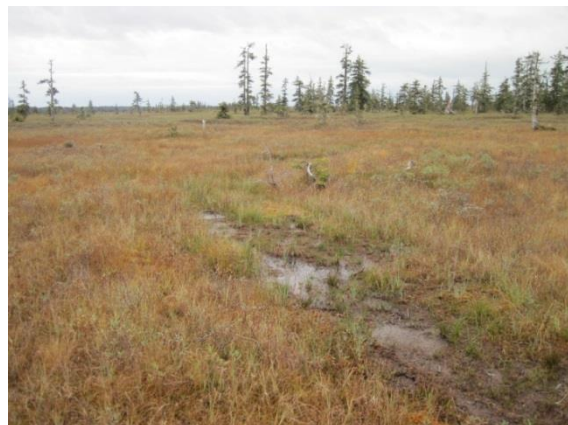
Photo Site 1

Vegetation and soils were well recovered along the access trail. There was no evidence of changes in the plant community. Ruts from the ATVs were barely evident in only a few sites where ATV traffic had passed through especially boggy areas. These type of sites, where the water table is close to the surface, are known to be vulnerable to ATV traffic and frequently take a long time to recover. Photo monitoring details can be found in appendix B.

Update taken 7/8/16

Original taken 9/24/10

Update taken 10/2/12

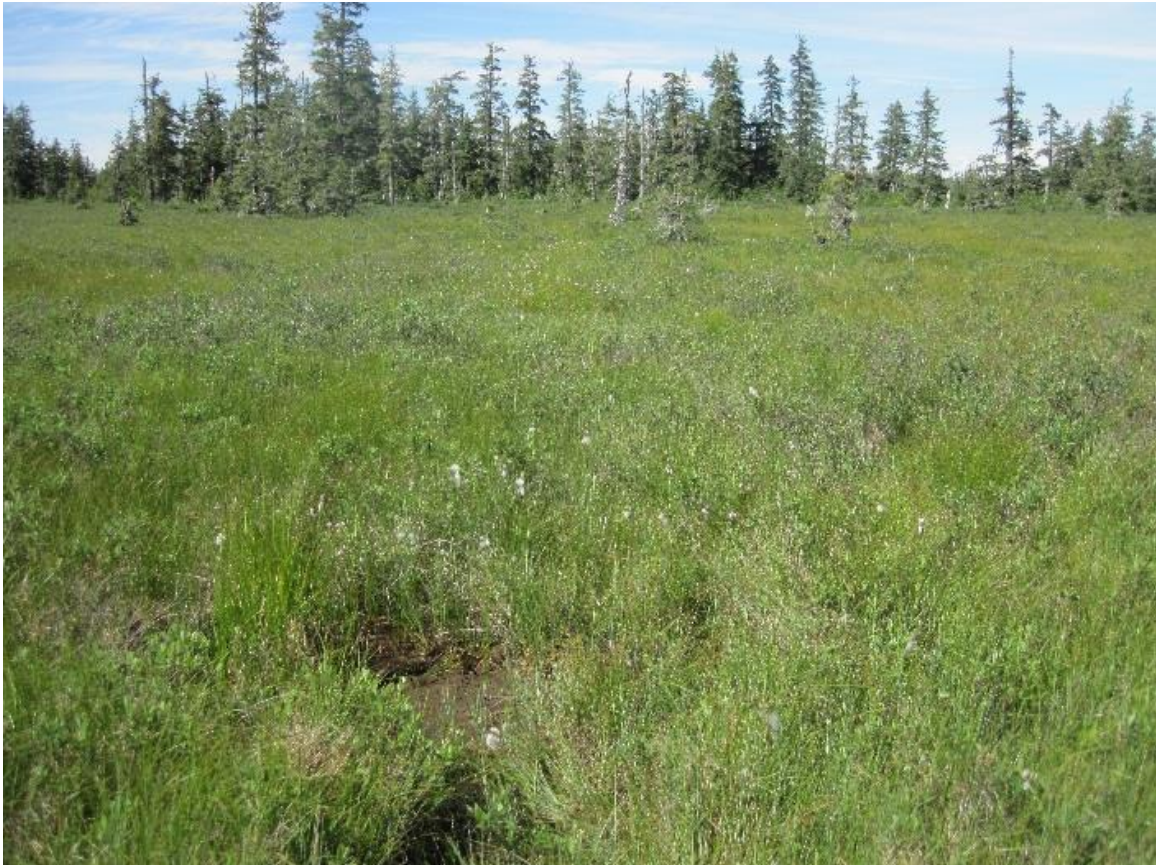
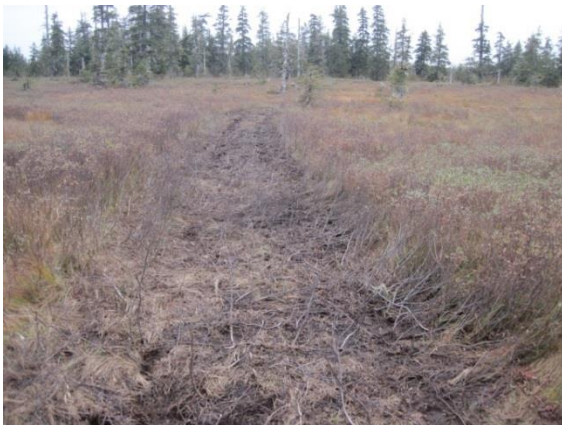
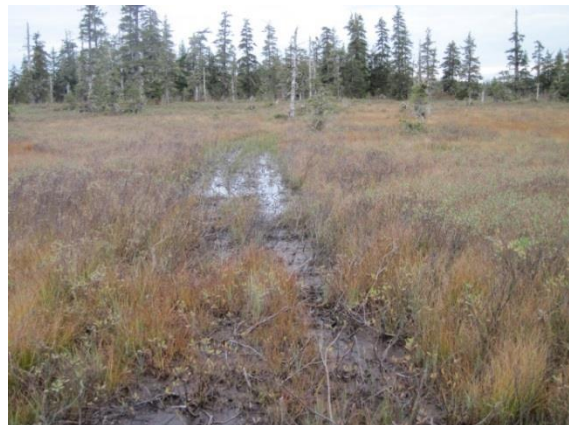
Photo Site 2

Update taken 7/8/16

Original taken 9/24/10

Update taken 10/2/12

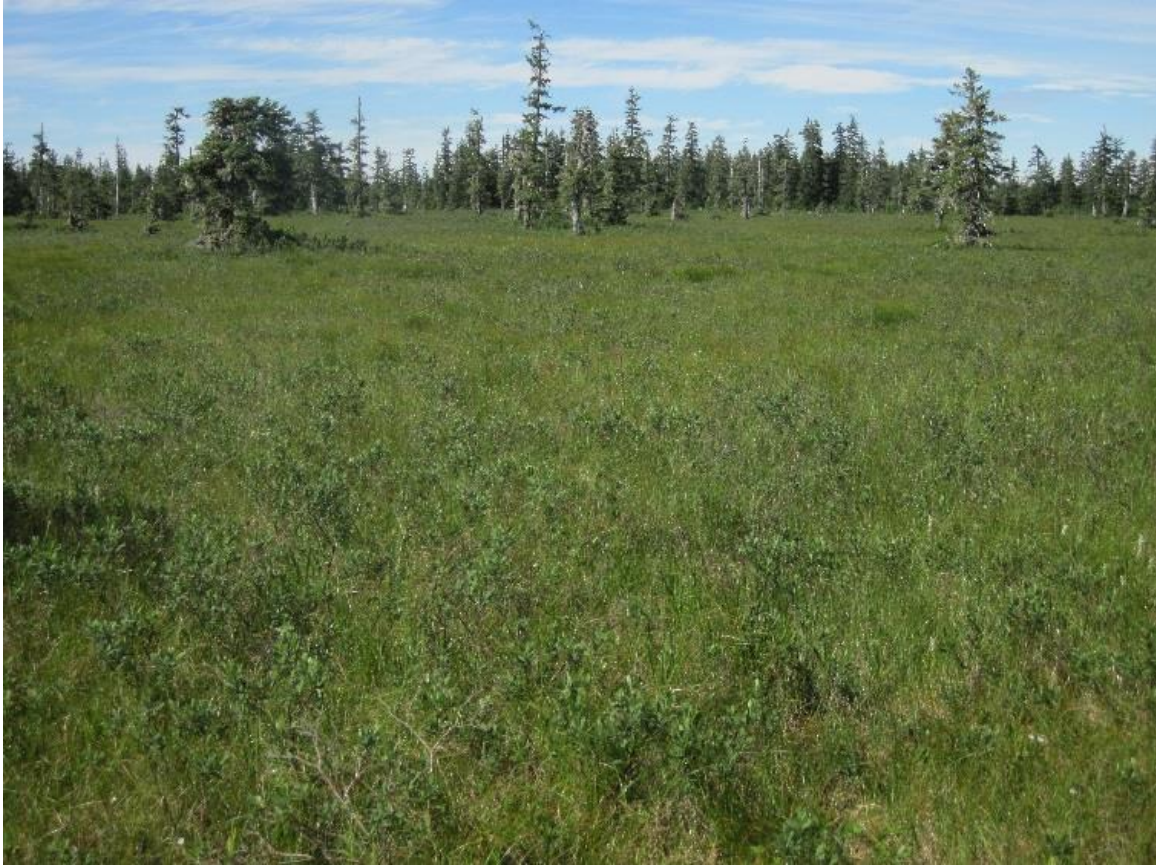
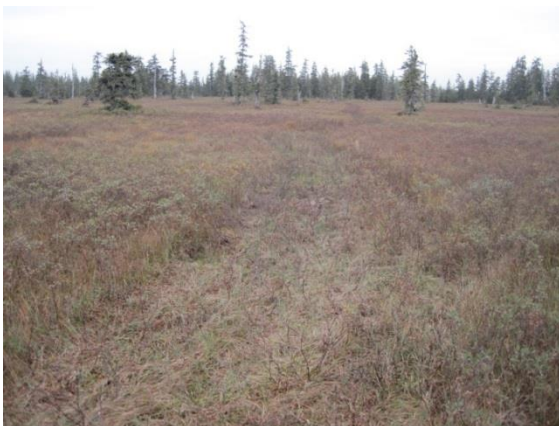
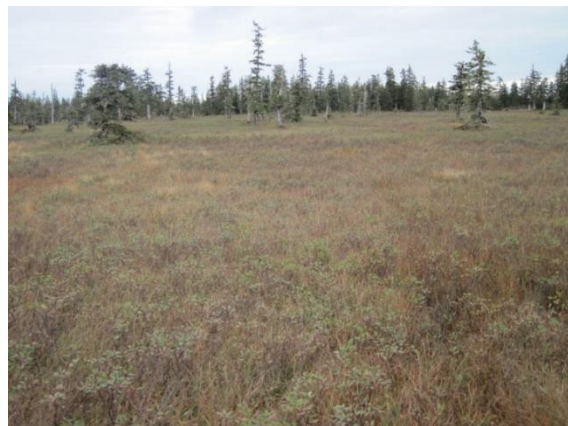
Photo Site 3

Update taken 7/8/16

Original taken 9/24/10

Update taken 10/2/12

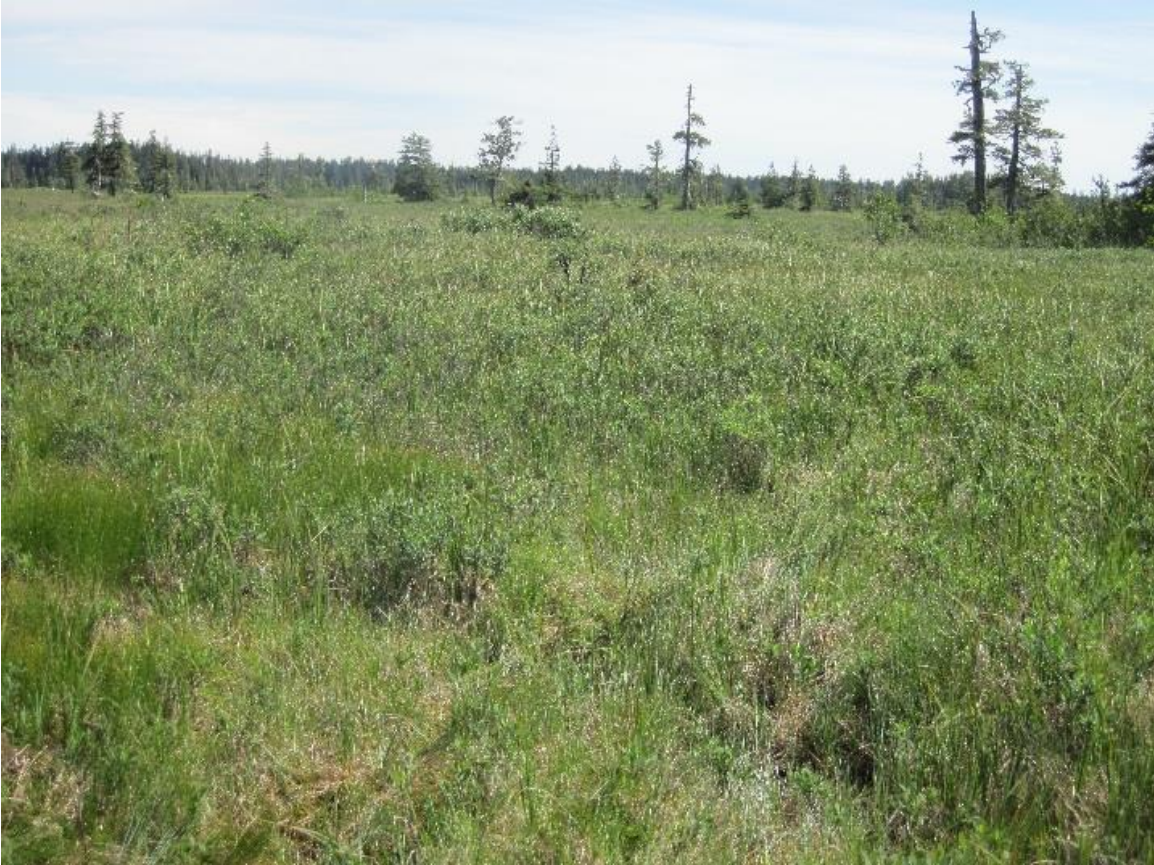
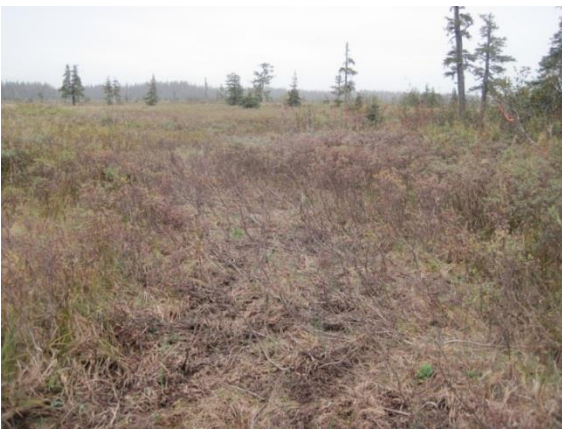
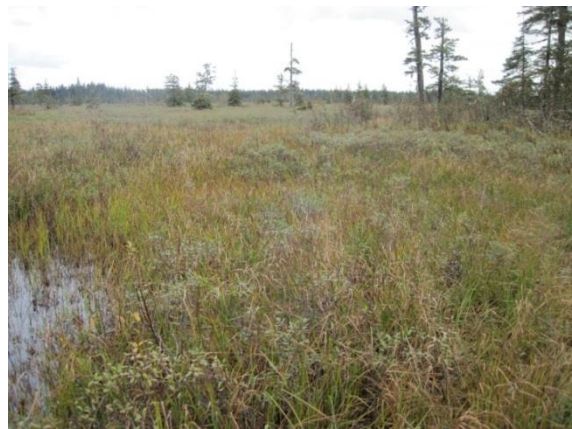
Photo Site 4

Update taken 7/8/16

Original taken 9/24/10

Update taken 10/2/12

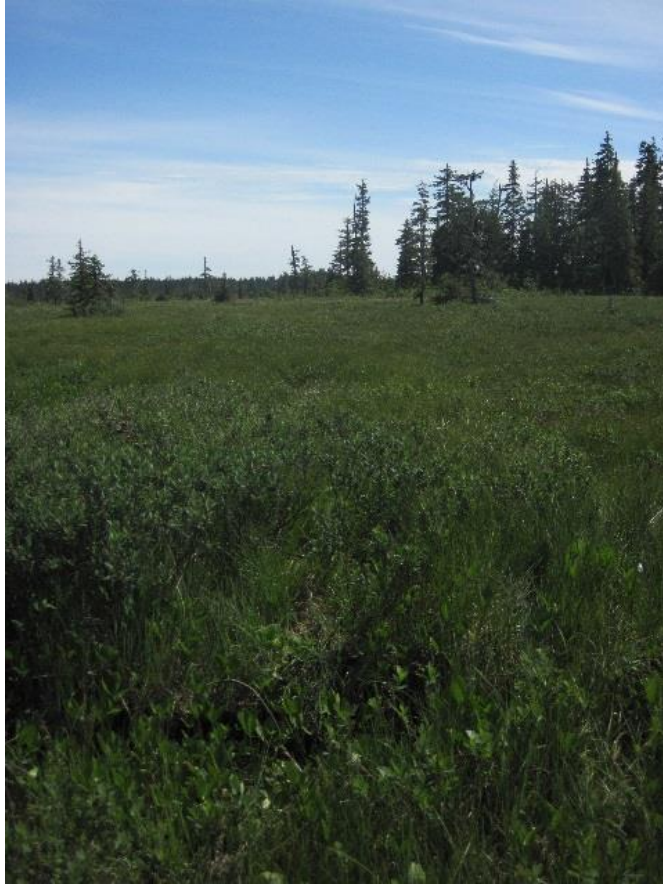
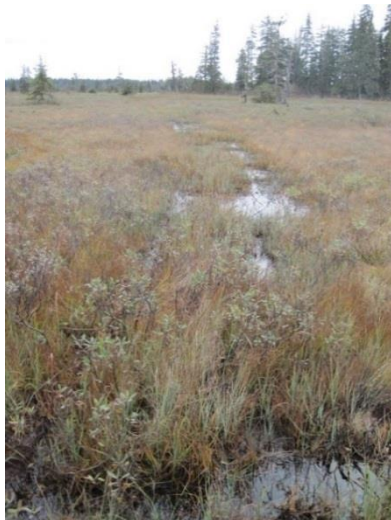
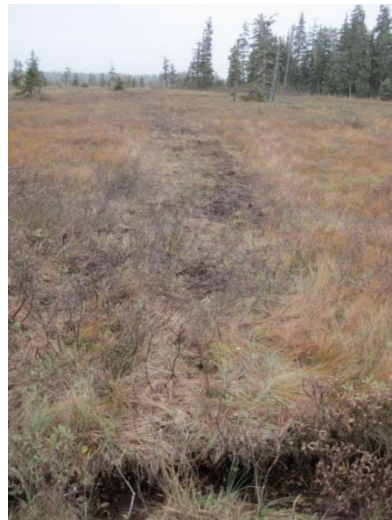
Photo Site 5

Update taken 7/8/16

Original taken 9/24/10

Update taken 10/2/12
