Lost River Restoration

Monitoring Report 2016

Nate Catterson, Fisheries Biologist

Yakutat Ranger District, Tongass National Forest

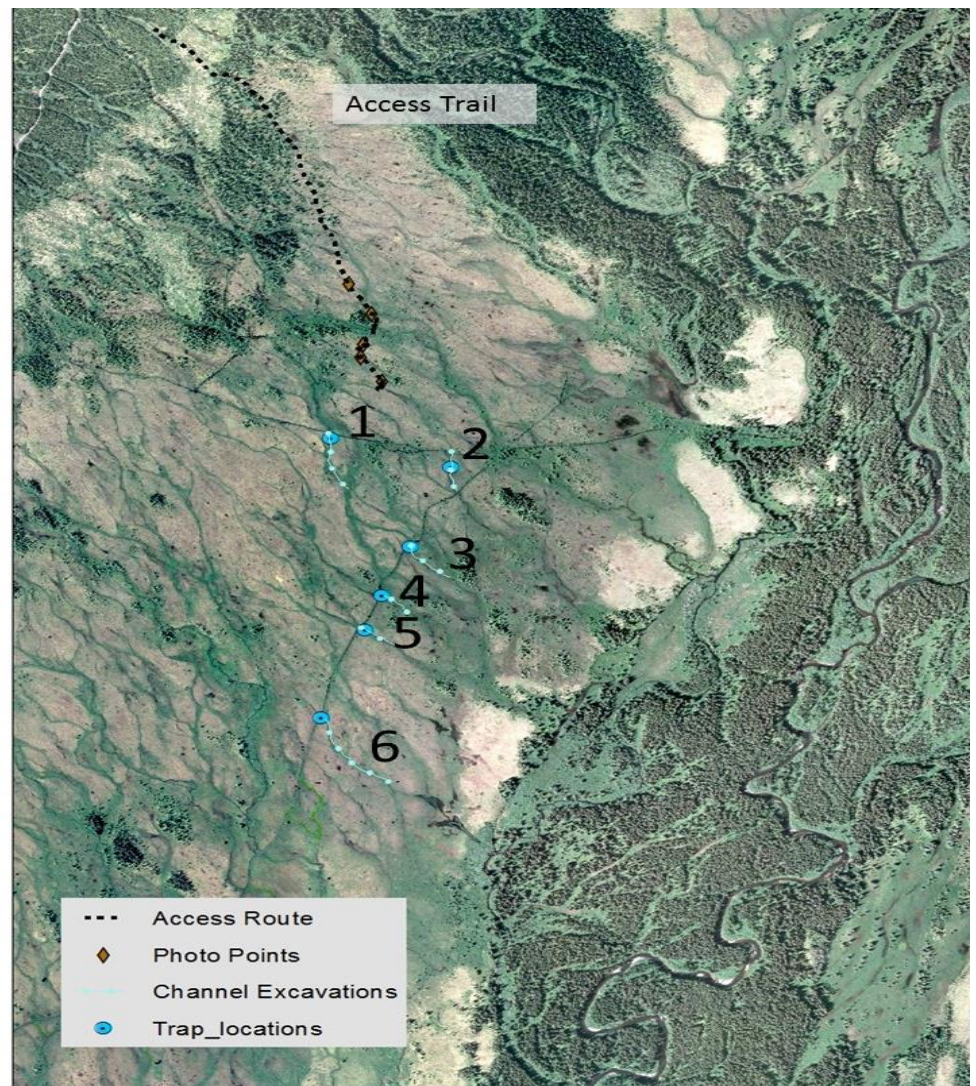
The restored stream channels provided fish habitat and maintained flow throughout the field season. No intermittent flow was observed in the restored channels, even when water levels were low in other streams on the Yakutat Forelands.
